# DAMAGE ASSESSMENT FORM

Building Name PALM LODGE

Address 17390 SW 296 STREET

Date of Construction ca. 1912 Folio No. 30-7907-000-0110

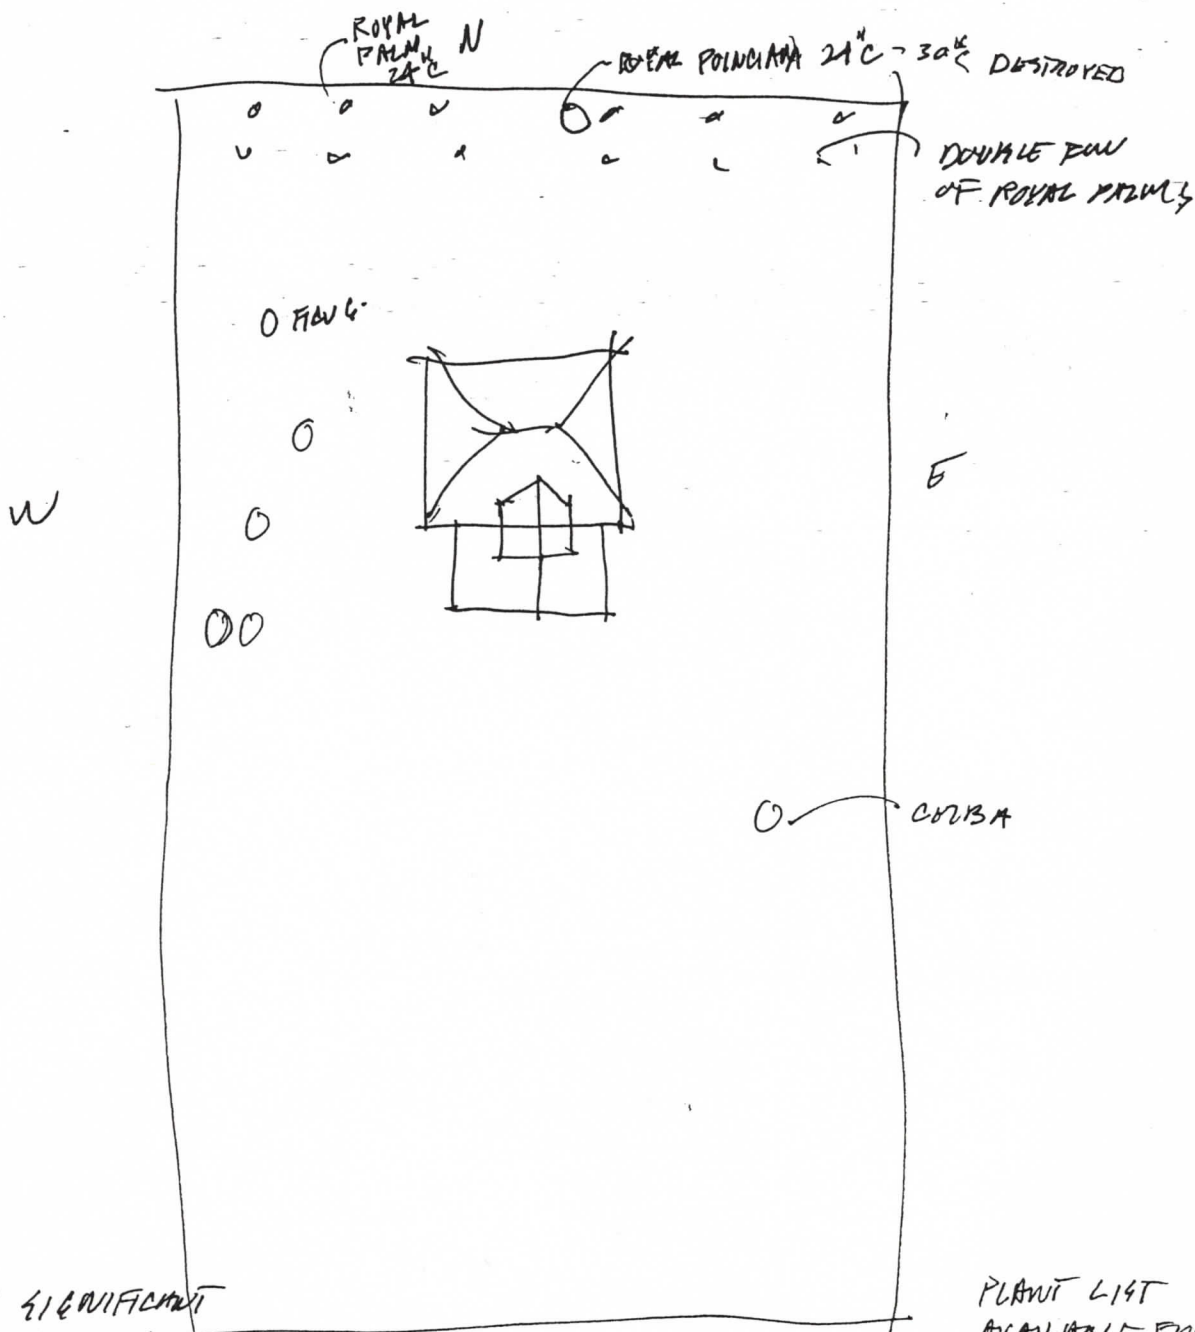
## Site Sketch:

LANDSCAPE IS SIGNIFICANT IN THE NUMBER AND VARIETY OF EXOTIC SPECIES. PLANT MATERIAL WAS UNDER THE DIRECTION OF FAIRGOLD.

PLANT LIST AVAILABLE FROM OWNER. ITS STORY FROM OWNER AND PEOPLE WHO HAVE TOUCHED THE PROPERTY.
